RESERVE STUDY

Charlesgate Village Association

Amherst, New York
October 15, 2021

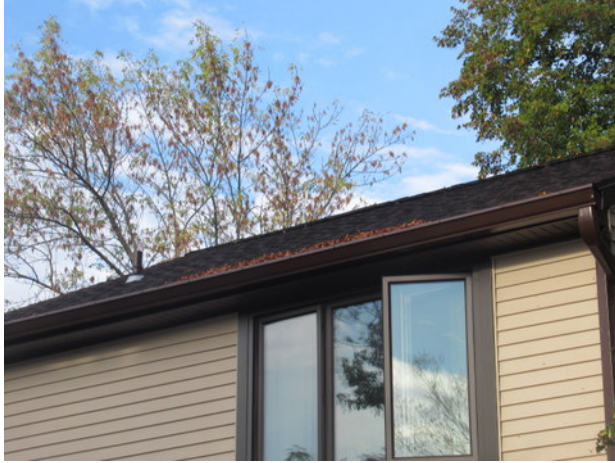
Natural debris buildup and deterioration in gutter of Unit 804

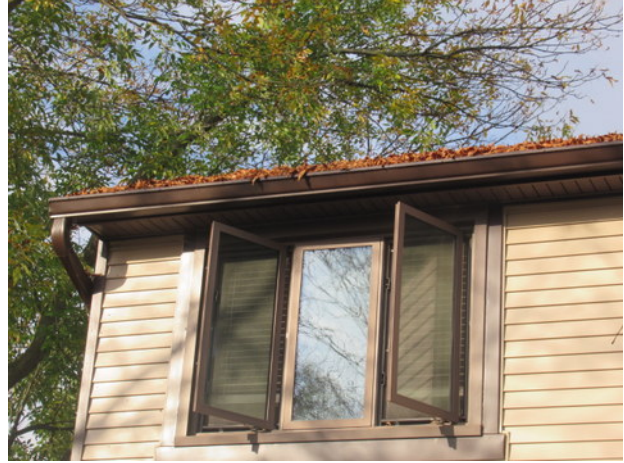
Natural debris buildup and deterioration in gutter of Unit 208

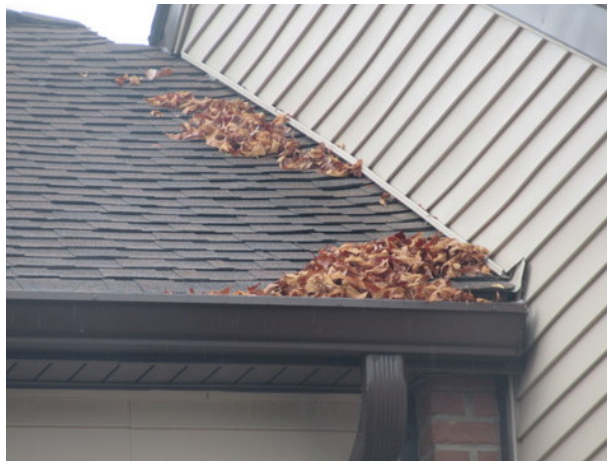
Natural debris buildup and deterioration in gutter of Unit 207

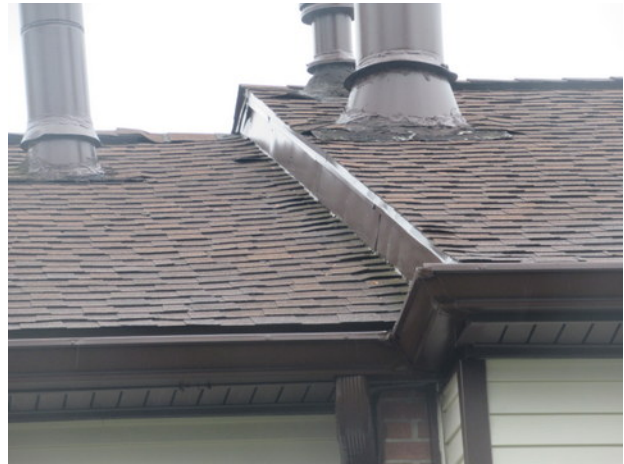
Shingle lift and deterioration at asphalt shingle roof of Unit 1007

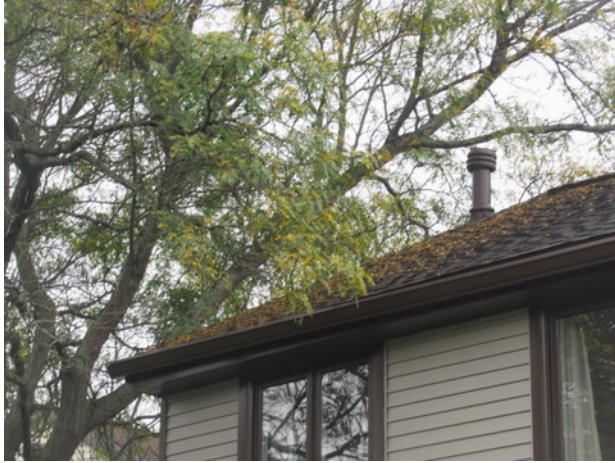
Overhanging and encroaching tree branches, natural debris buildup and deterioration at asphalt shingle roof of Unit 406

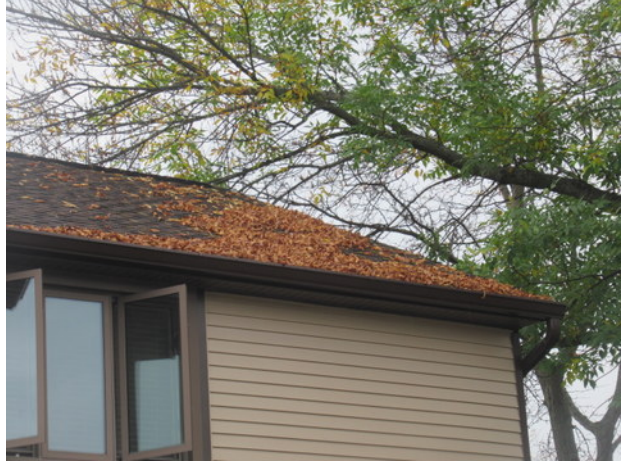
Overhanging and encroaching tree branches, natural debris buildup and deterioration at asphalt shingle roof of Unit 208

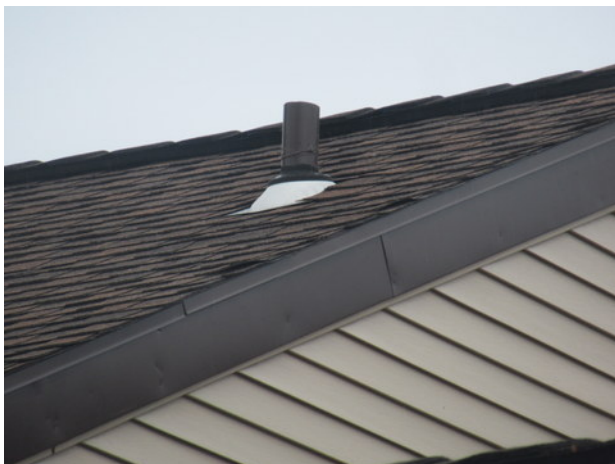
Shingle lift and deterioration at asphalt shingle roof of Unit 356

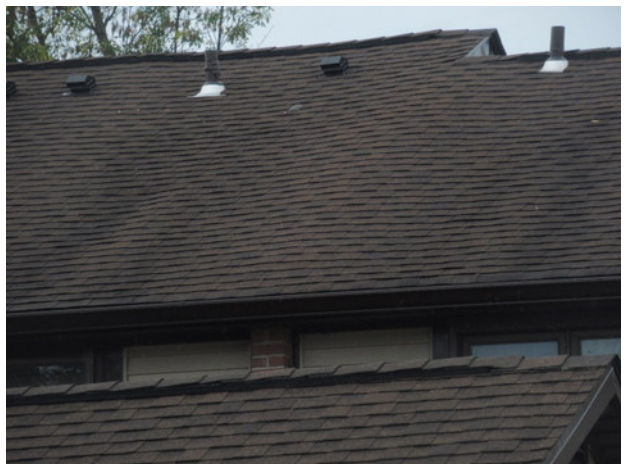
Shingle lift, stains and deterioration at asphalt shingle roof of Unit 551

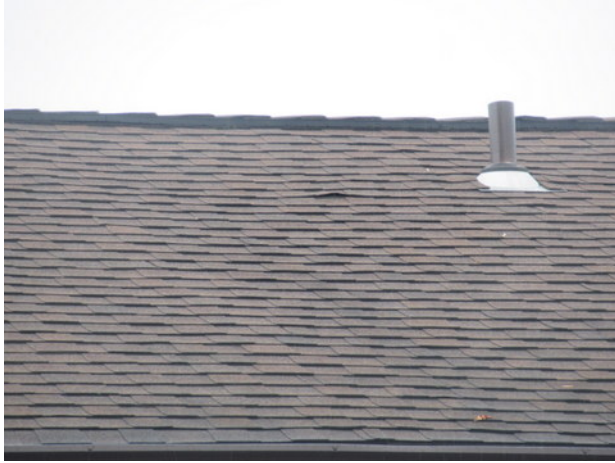
Shingle lift and deterioration at asphalt shingle roof of Unit 554

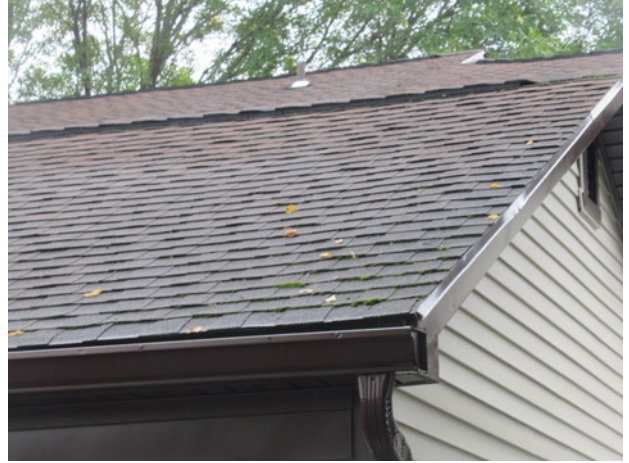
Shingle lift, organic growth and deterioration at asphalt shingle roof of Unit 654

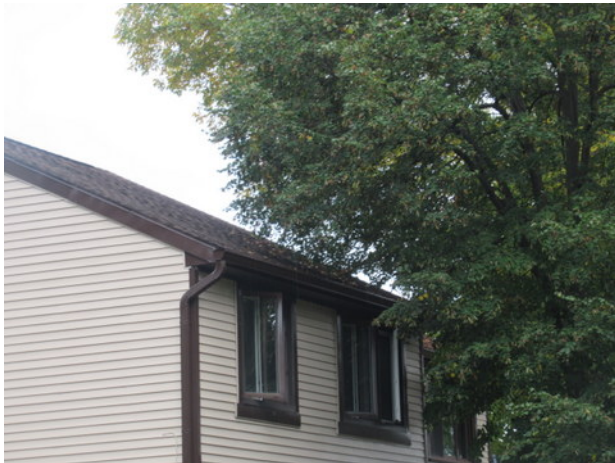
Overhanging and encroaching tree branches, and deterioration at asphalt shingle roof of Unit 603

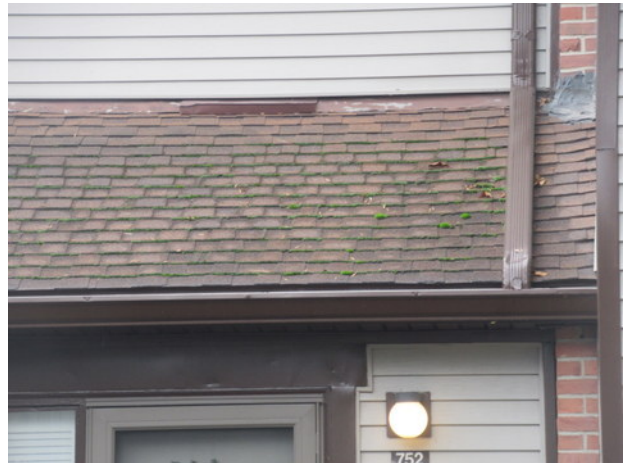
Organic growth and deterioration at asphalt shingle roof of Unit 752

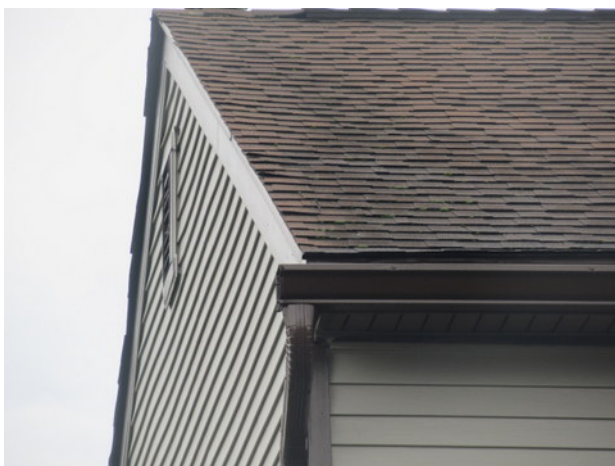
Shingle lift and deterioration at asphalt shingle roof of Unit 754

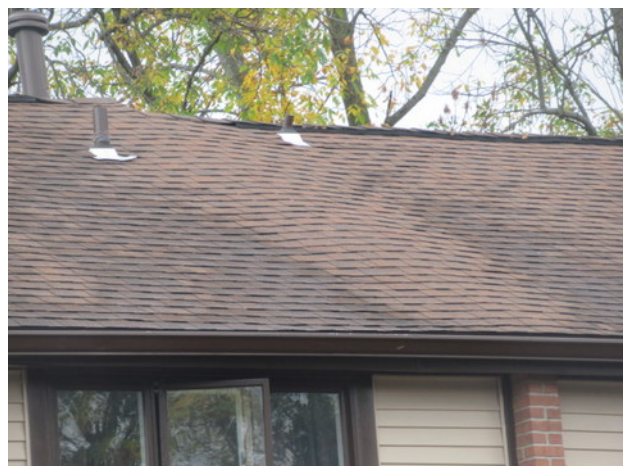
Sheathing deflection and deterioration at asphalt shingle roof of Unit 1353

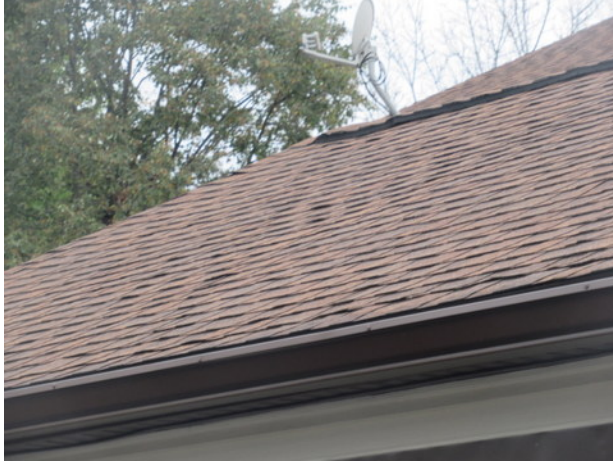
Shingle lift and deterioration at asphalt shingle roof of Unit 1755

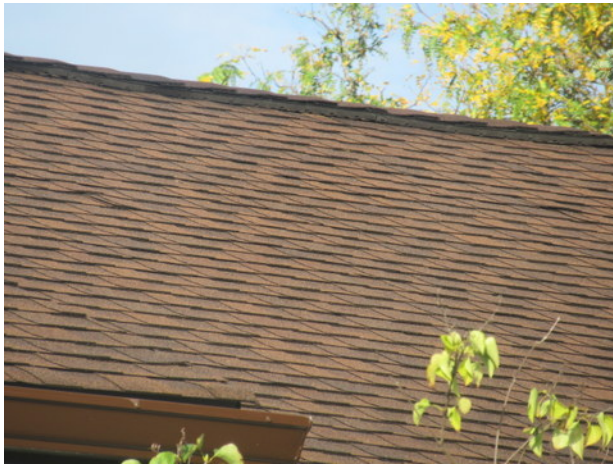
Shingle lift and deterioration at asphalt shingle roof of Unit 502

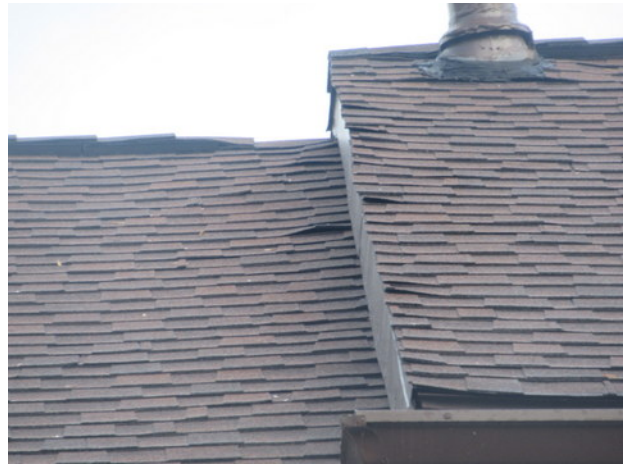
Shingle lift and deterioration at asphalt shingle roof of Unit 907

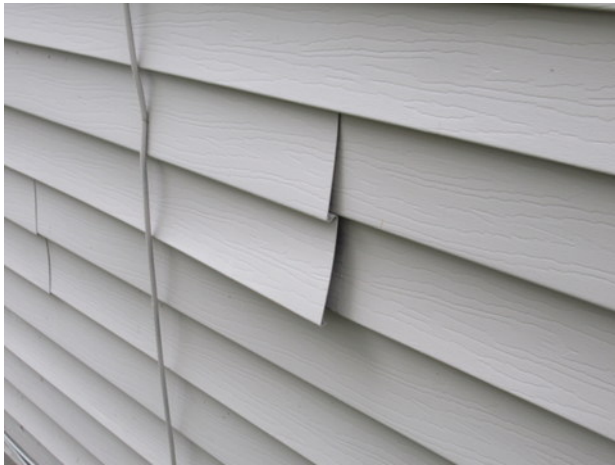
Loose siding and deterioration at vinyl siding of Unit 251

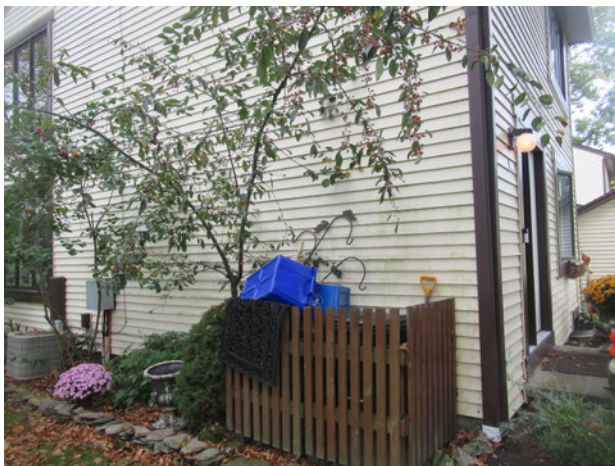
Encroaching tree branches and deterioration at vinyl siding of Unit 1254

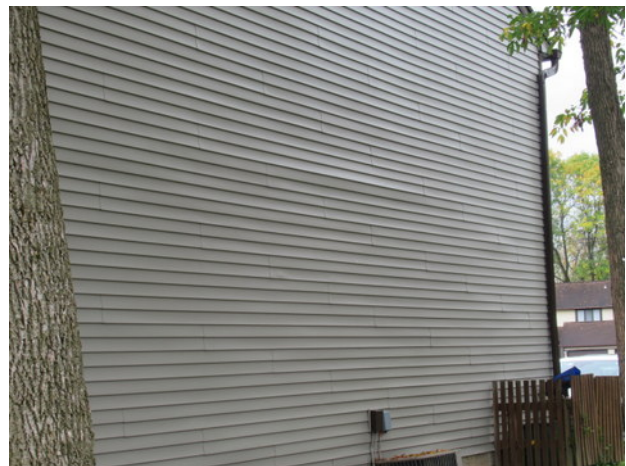
Bulging and deterioration at vinyl siding of Unit 1454

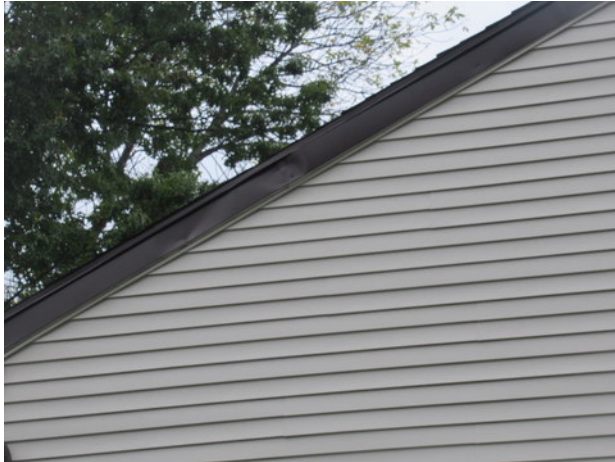
Damage and deterioration at fascia cladding of Unit 1756

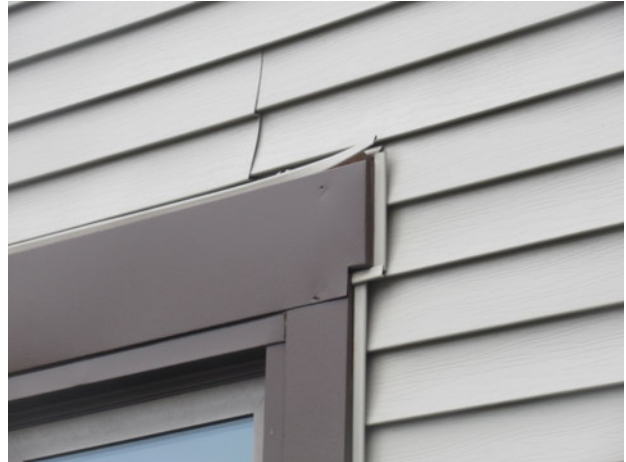
Loose J-channel and deterioration at vinyl siding of Unit 1451

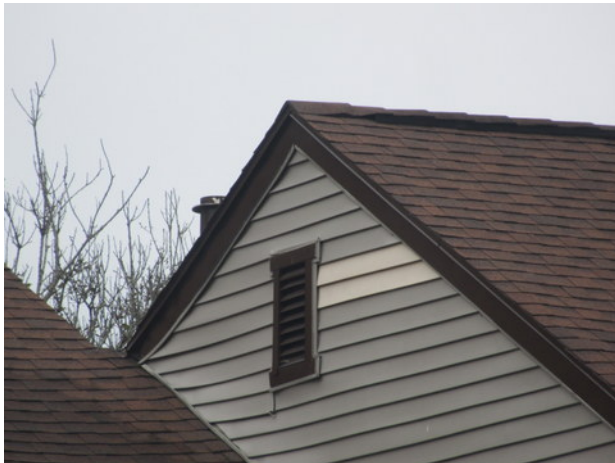
Previous partial siding replacement, warping and deterioration at vinyl siding of Unit 1452

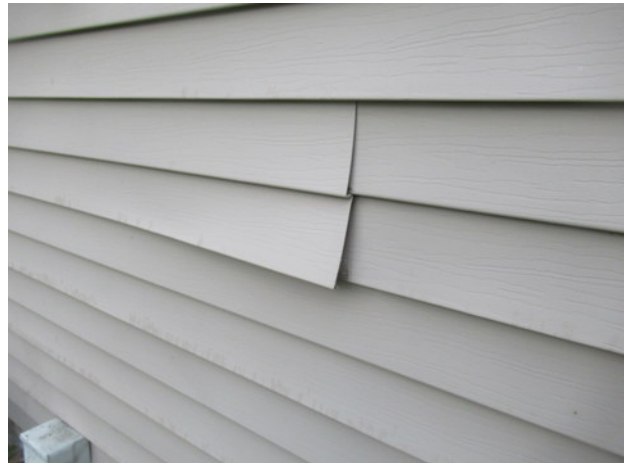
Loose siding and deterioration at vinyl siding of Unit 1304

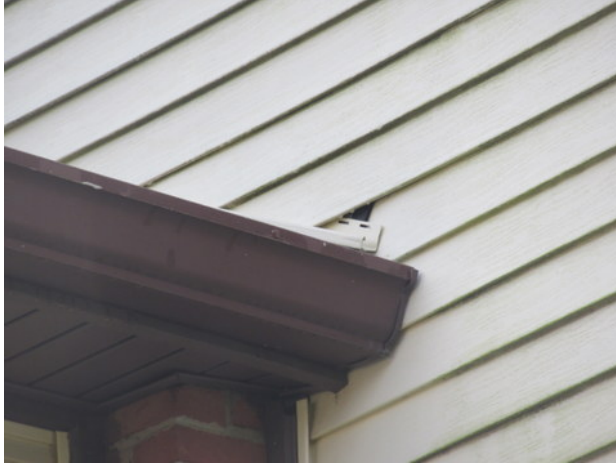
Gap and deterioration at vinyl siding of Unit 851

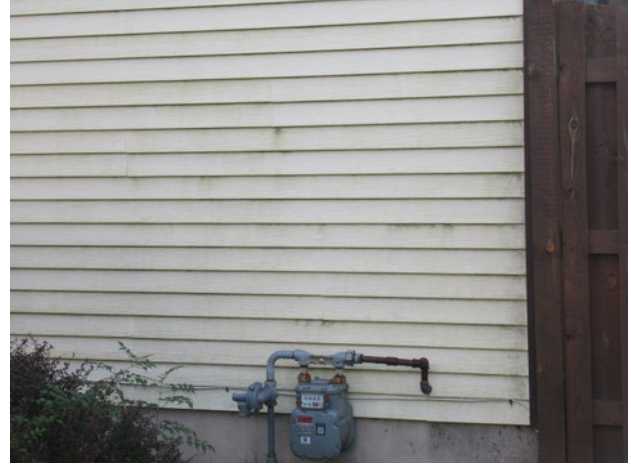
Organic stains and deterioration at vinyl siding of Unit 851

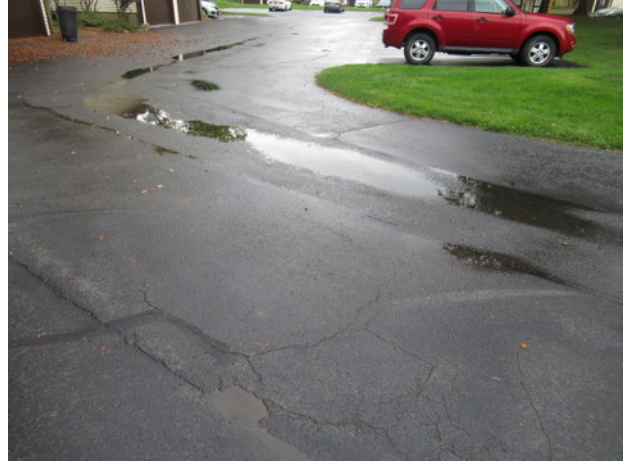
Lateral and longitudinal cracks, previous crack and patch repairs, standing water and deterioration at asphalt pavement near Unit 1102

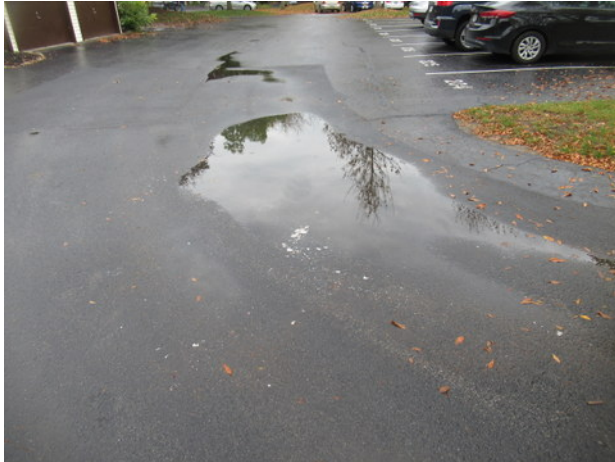
Lateral and longitudinal cracks, previous crack and patch repairs, standing water and deterioration at asphalt pavement near Unit 303

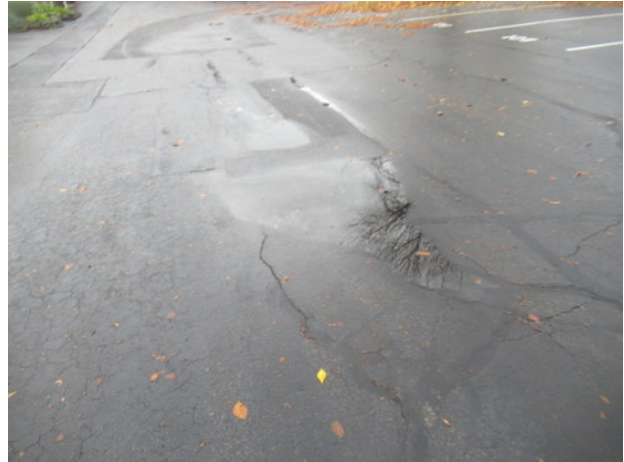
Lateral and longitudinal cracks, previous crack and patch repairs, standing water and deterioration at asphalt pavement near Unit 103

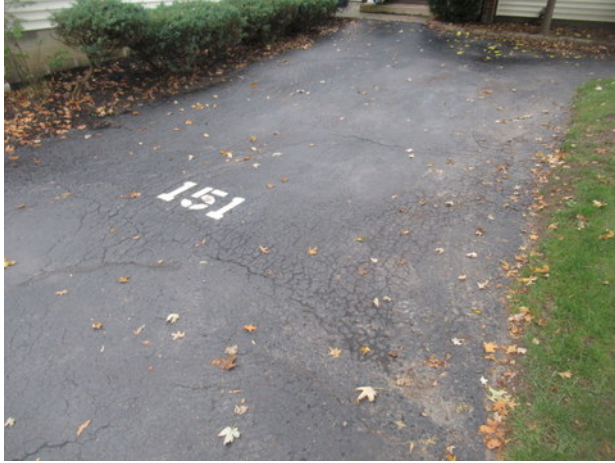
Spider and alligator cracks, and deterioration at asphalt pavement near Unit 151

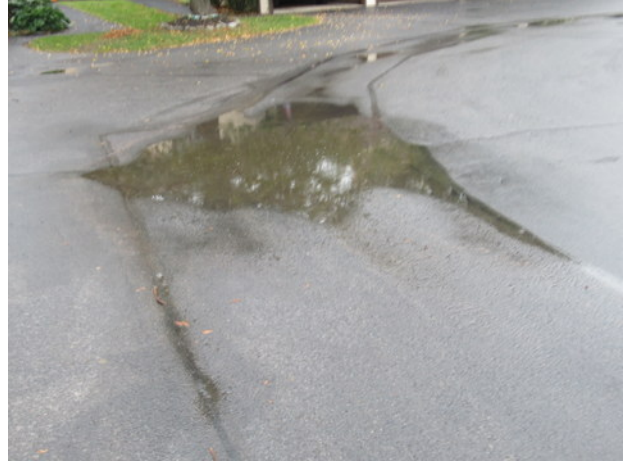
Longitudinal cracks, previous crack and patch repairs, standing water and deterioration at asphalt pavement near Unit 452

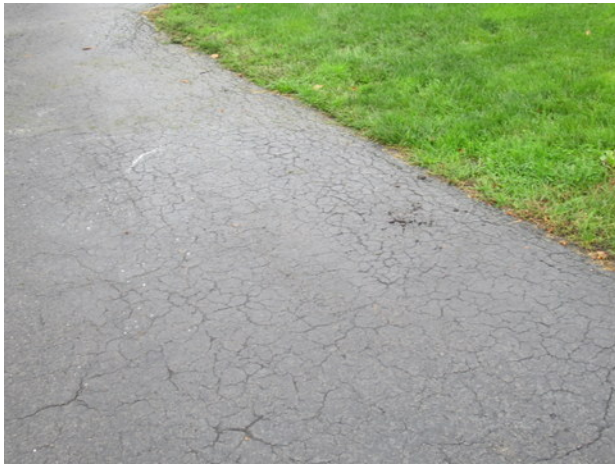
Spider and alligator cracks, and deterioration at asphalt pavement near Unit 353

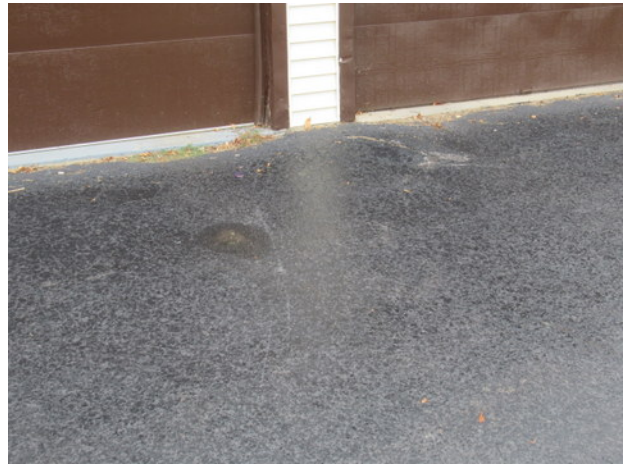
Minor settlement and deterioration at interface of asphalt pavement/garage threshold near Unit 455

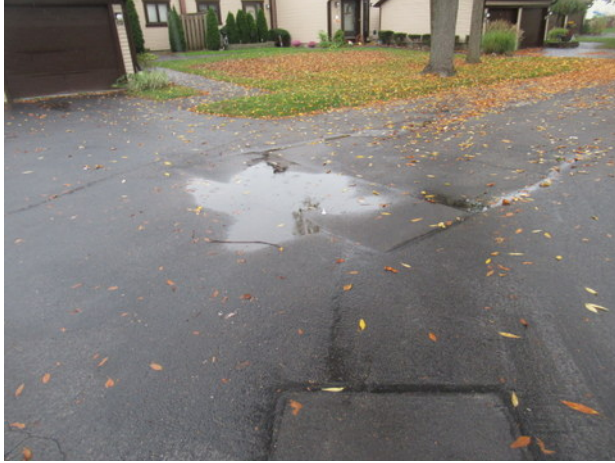
Lateral and longitudinal cracks, previous crack and patch repairs, standing water and deterioration at asphalt pavement near Unit 557

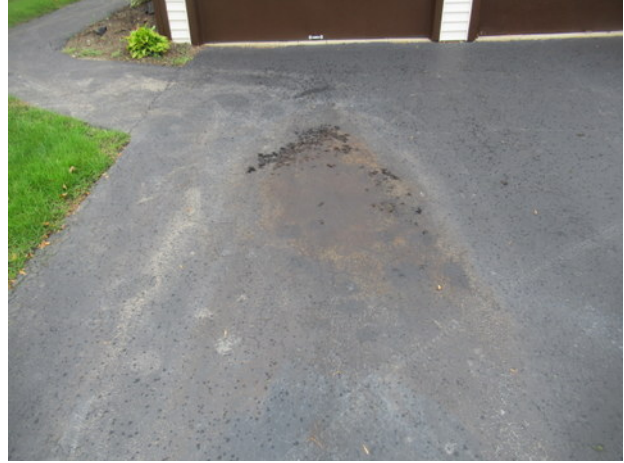
Vehicle fluid stains and deterioration at asphalt pavement near Unit 704

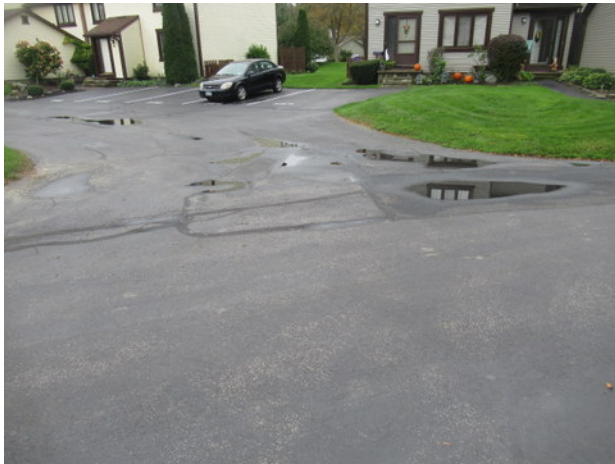
Lateral and longitudinal cracks, previous crack and patch repairs, standing water and deterioration at asphalt pavement near Unit 754

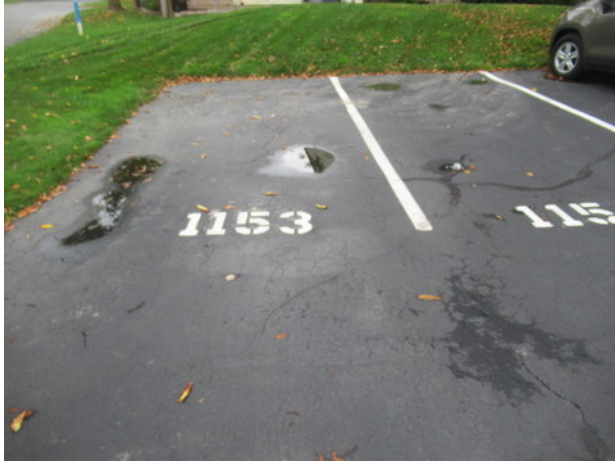
Spider cracks, rutting, standing water and deterioration at asphalt pavement near Unit 1153

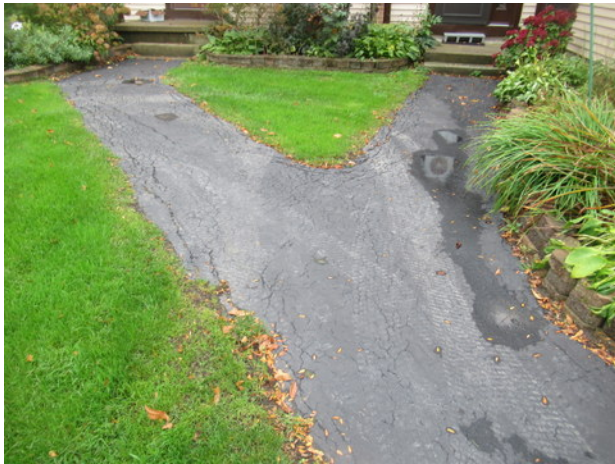
Longitudinal, edge and alligator cracks, standing water and deterioration at asphalt pavement near Unit 1555

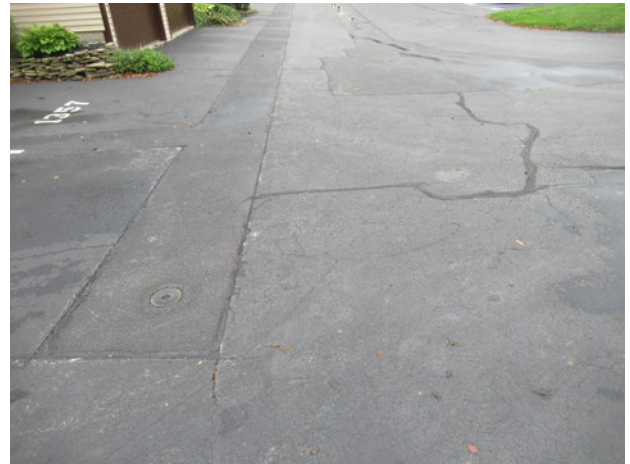
Lateral and longitudinal cracks, previous patch repairs and deterioration at asphalt pavement near Unit 1357

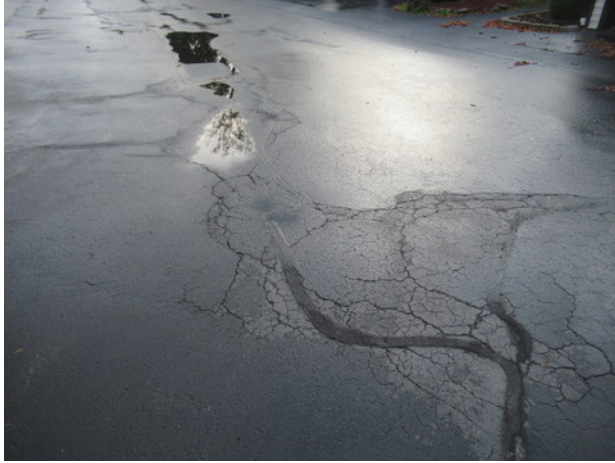
Lateral, longitudinal and alligator cracks, previous crack repairs, standing water and deterioration at asphalt pavement near Unit 1452

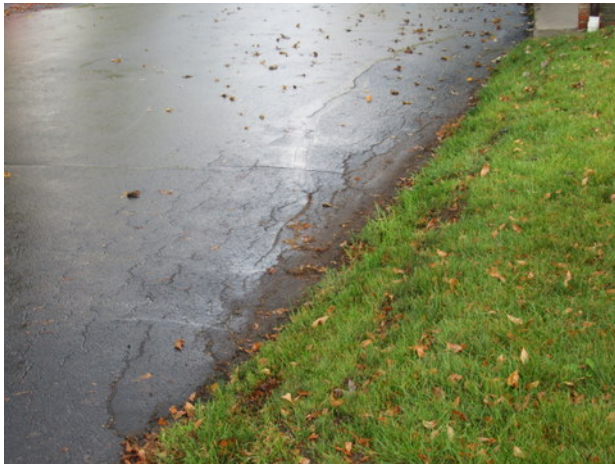
Alligator and edge cracks, and deterioration at asphalt pavement near Unit 1056

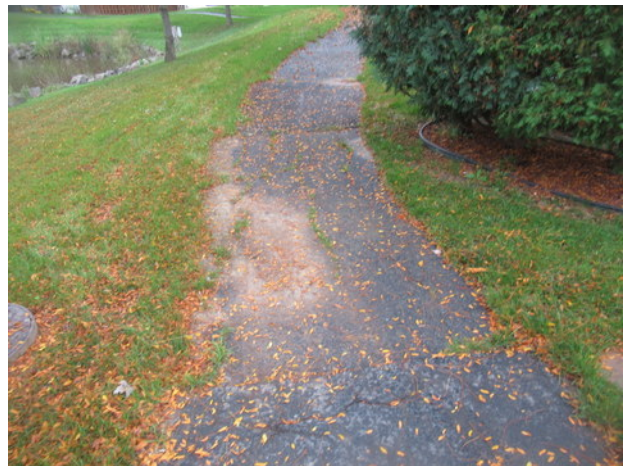
Lateral cracks, previous patch repair, organic growth, minor settlement and deterioration at asphalt walking path near Unit 1008

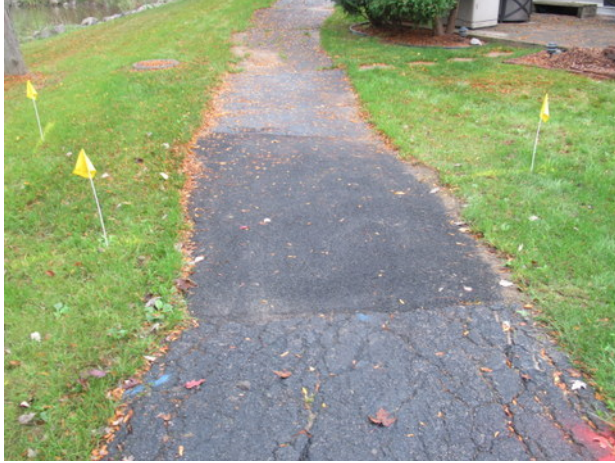
Longitudinal, edge and alligator cracks, previous patch repair and deterioration at asphalt walking path near Unit 1007

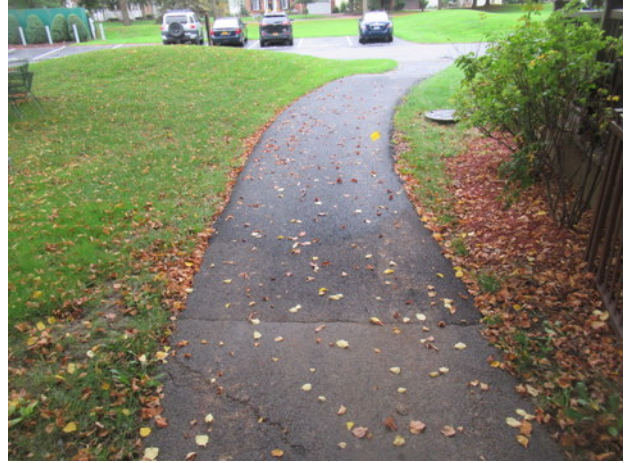
Previous patch repair at asphalt walking path near Unit 603

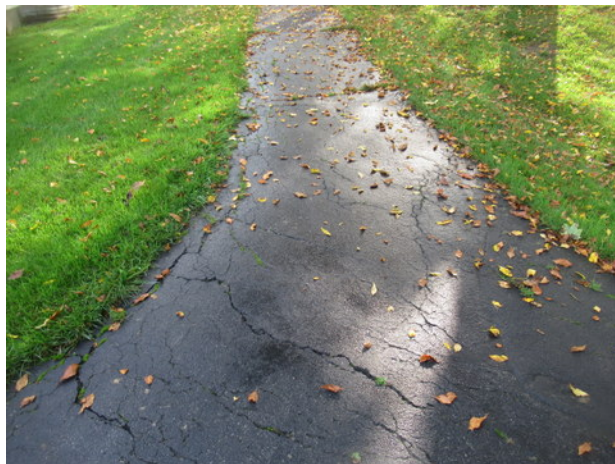
Longitudinal, lateral, edge and alligator cracks, and deterioration at asphalt walking path near Unit 1001

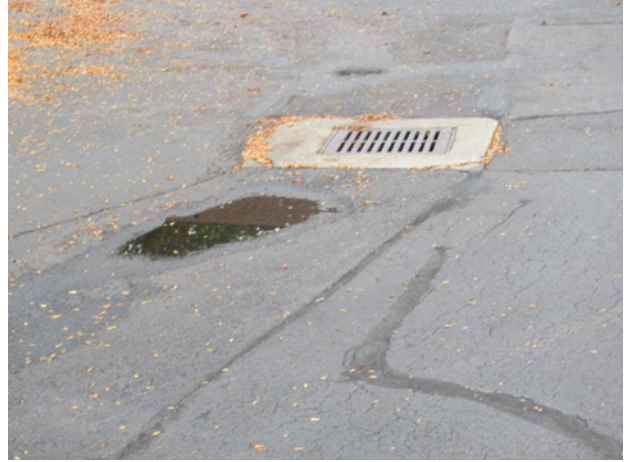
Negative drainage flow, minor settlement and deterioration at catch basin near Unit 1652

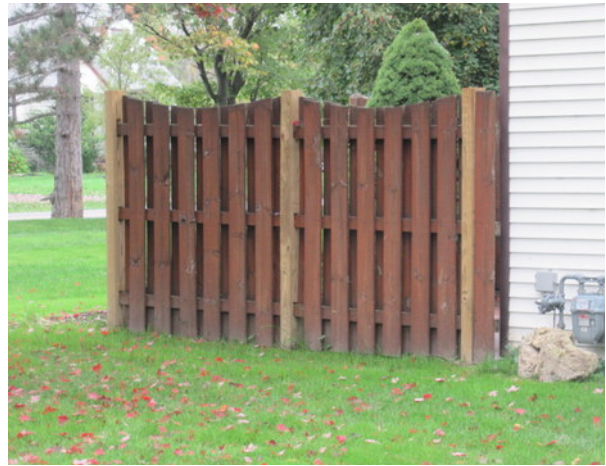
Previous fence post replacement and deterioration at wood privacy fence near Unit 156

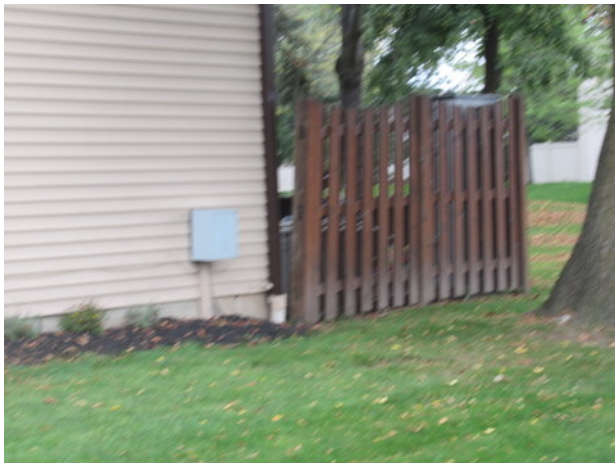
Leaning fence section and deterioration at wood privacy fence near Unit 1408

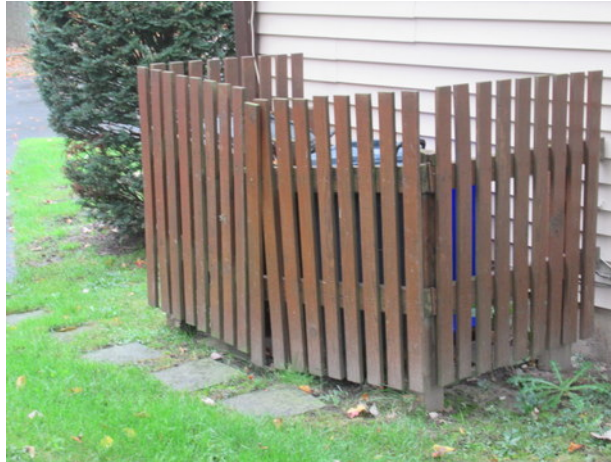
Leaning fence section and deterioration at wood refuse area fences near Unit 251

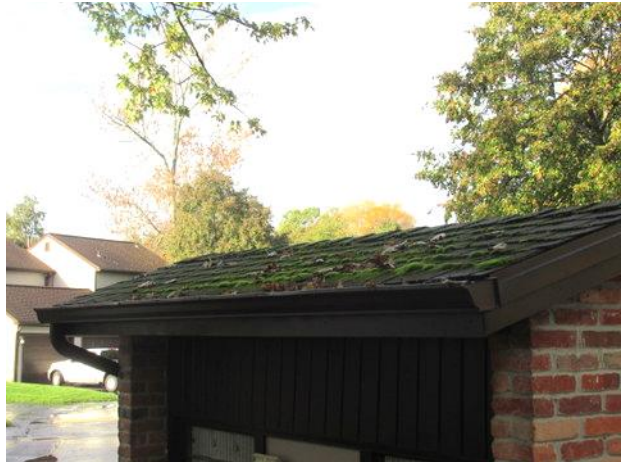
Organic growth and deterioration at asphalt shingle roof of mailbox shelter near Unit 1056

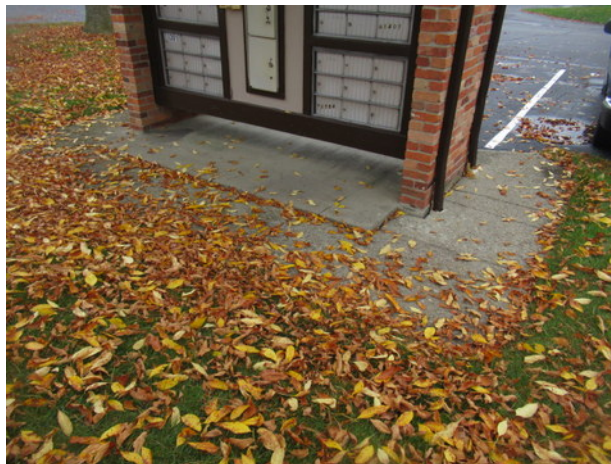
Cracks and deterioration at concrete pad of mailbox shelter near Unit 1454
