RESERVE STUDY

Charlesgate Village Association

Amherst, New York
October 15, 2021

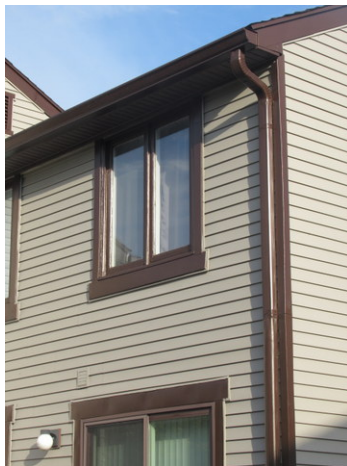
Condition: Good to fair overall condition with natural debris buildup and deterioration evident

Aluminum gutter and downspout overview

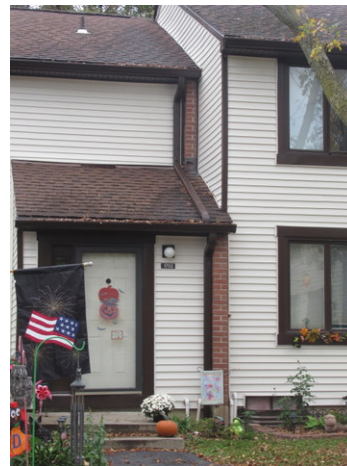
Aluminum gutter and downspout overview

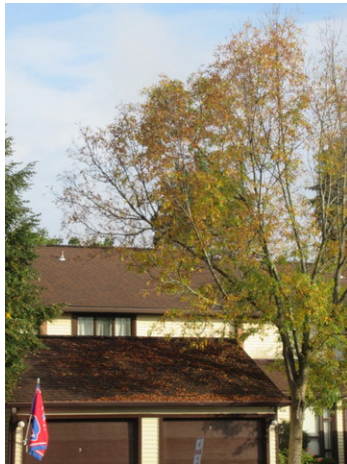
Overhanging and encroaching tree branches, natural debris buildup and deterioration at asphalt shingle roof of Unit 1103

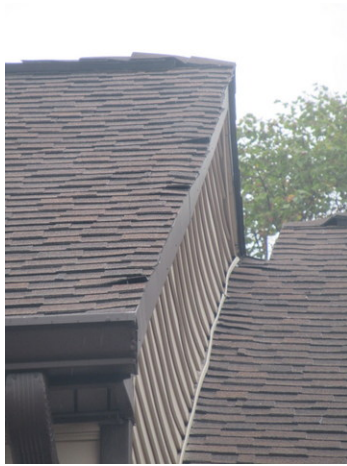
Shingle lift and deterioration at asphalt shingle roof of Unit 203

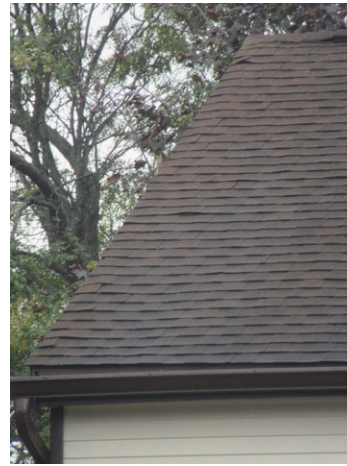
Shingle lift and deterioration at asphalt shingle roof of Unit 301

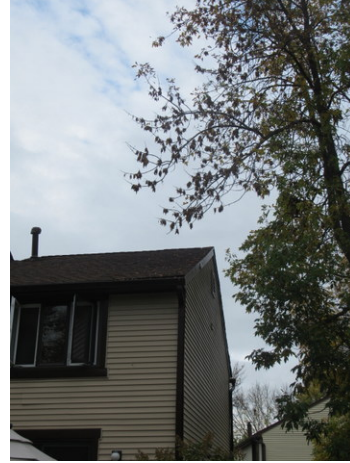
Overhanging and encroaching tree branches, and deterioration at asphalt shingle roof of Unit 1556

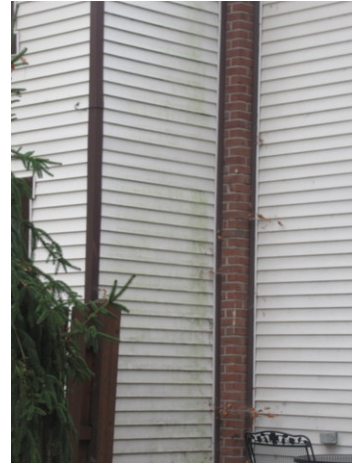
Organic stains and deterioration at vinyl siding of Unit 101

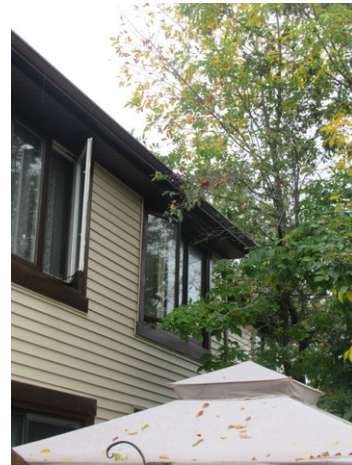
Encroaching tree branches and deterioration at vinyl siding of Unit 354

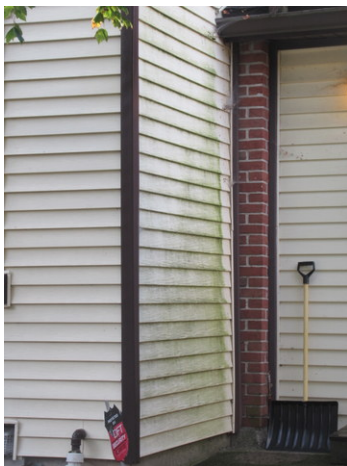
Organic stains and deterioration at vinyl siding of Unit 853

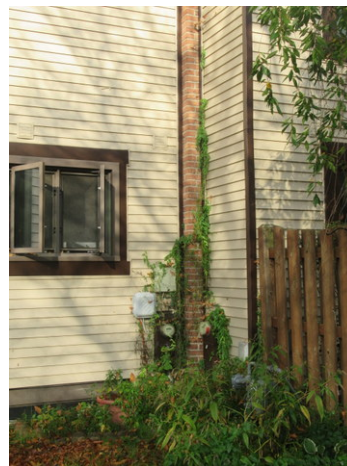
Vegetation overgrowth and deterioration at vinyl siding of Unit 208

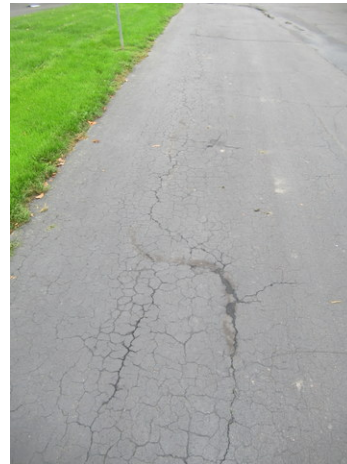
Spider, longitudinal and alligator cracks, and deterioration at asphalt pavement near Unit 851

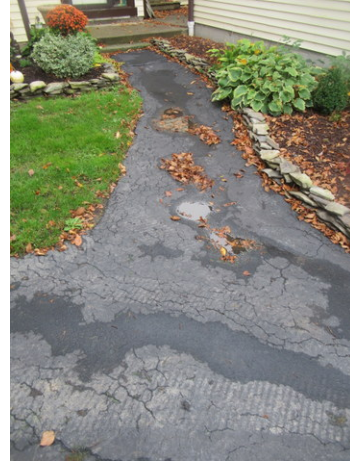
Spider cracks, standing water and deterioration at asphalt pavement near Unit 1253

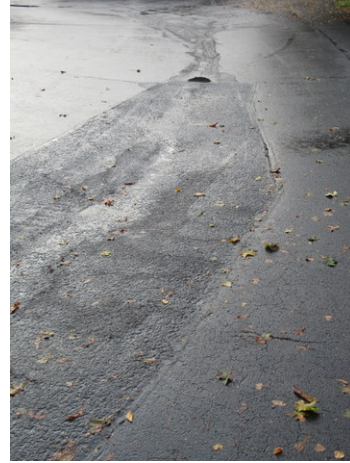
Longitudinal cracks, previous patch repairs, standing water and deterioration at asphalt pavement near Unit 1302

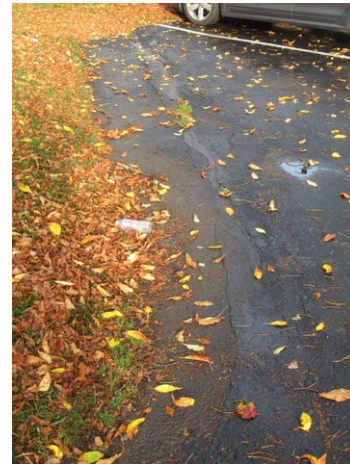
Lateral cracks, standing water and deterioration at asphalt pavement near Unit 804

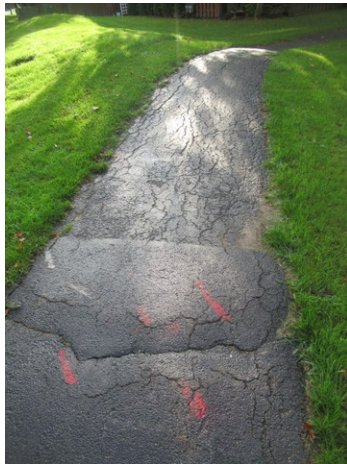
Spider, edge and alligator cracks, previous patch repairs and deterioration at asphalt walking path near Unit 1208

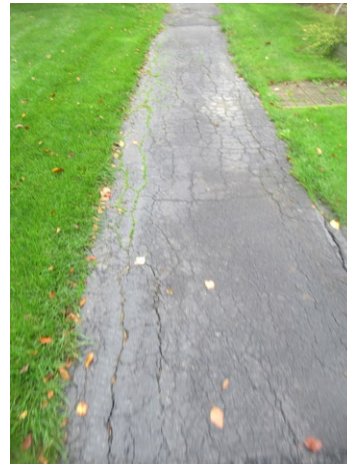
Longitudinal, edge and alligator cracks, organic growth and deterioration at asphalt walking path near Unit 1053

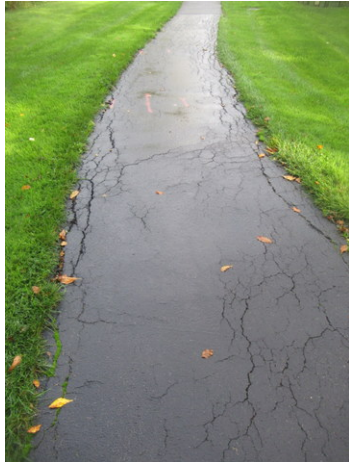
Longitudinal, lateral, edge and alligator cracks, and deterioration at asphalt walking path near Unit 1001

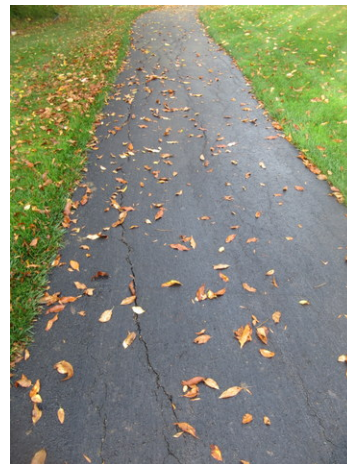
Longitudinal, edge and alligator cracks, and deterioration at asphalt walking path near Unit 706

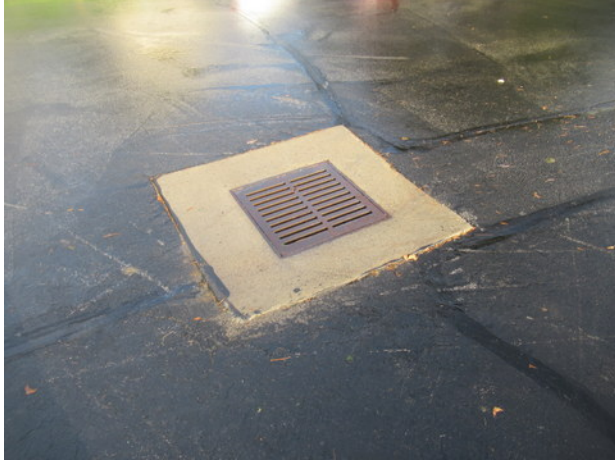
Condition: Good to fair overall condition with negative drainage flow, minor settlement and deterioration visually apparent

Typical catch basin

Expenditure Detail Notes: Expenditure timing and costs are depicted in the **Reserve Expenditures** table in Section 3. We recommend the Association plan for inspections and capital repairs to the catch basins in conjunction with repaving.

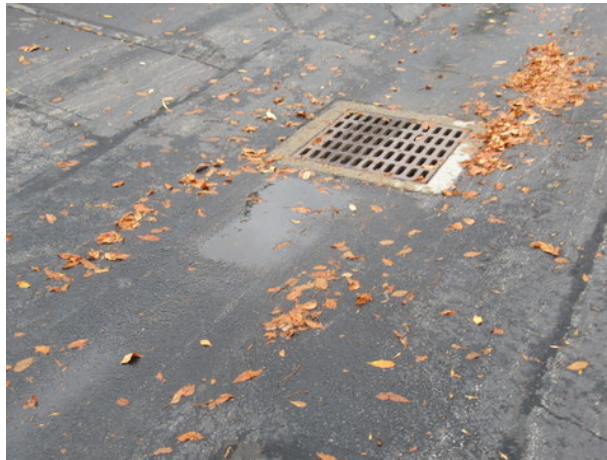
Negative drainage flow, minor settlement and deterioration at catch basin near Unit 1353

Component Detail Notes: Erosion causes settlement around the collar of catch basins. Left unrepaired, the entire catch basin will shift and need replacement.

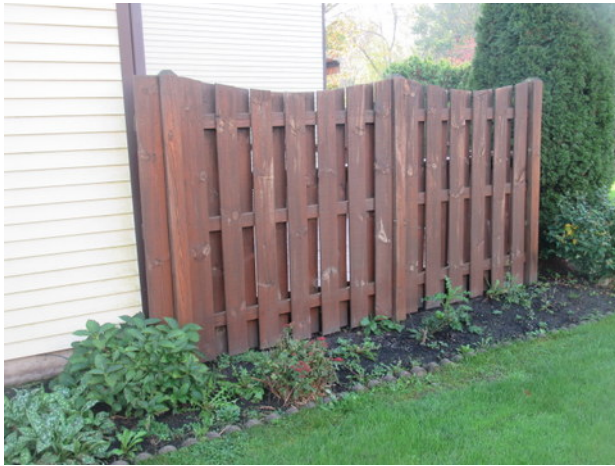
- Privacy: approximately 1,880 linear feet of shadowbox wood privacy fences; located perpendicular to the unit rear elevations; date to 1993; fair overall condition with previous partial replacements, leaning sections and deterioration evident

Typical wood privacy fence perpendicular to unit rear elevation

Expenditure Detail Notes: Expenditure timing and costs are depicted in the **Reserve Expenditures** table in Section 3. The Association should anticipate periodic partial replacements due to the non-uniform nature of wood deterioration. Along with these partial replacements, the Association should apply periodic paint applications as needed and fund these activities through the operating budget.

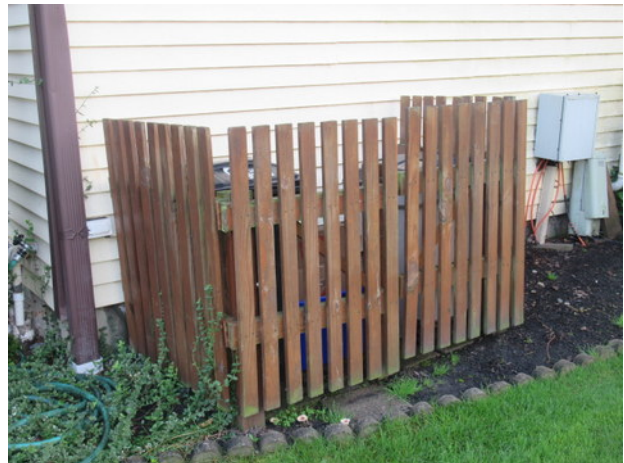
- Refuse areas: 64 wood picket fences; located at the side elevations of the buildings; date to 2008 and 2009; fair overall condition with leaning sections and deterioration evident

Typical wood refuse area fences located at the side elevation of building

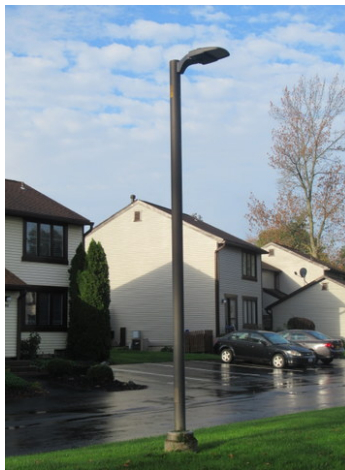
Condition: Good overall condition with no significant deterioration evident

Typical light pole and fixture
