RESERVE STUDY

Charlesgate Village Association

Amherst, New York
October 15, 2021

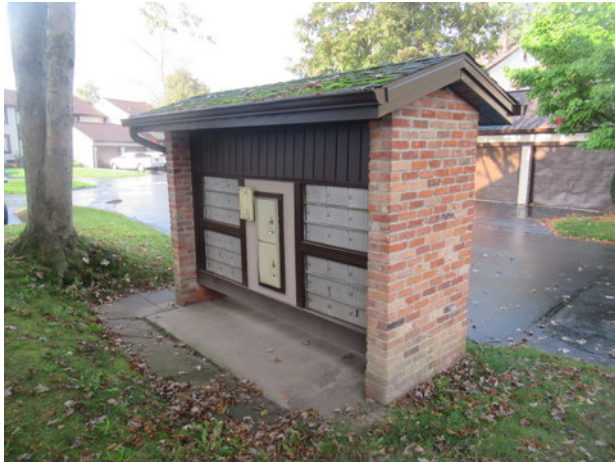
Condition: Fair overall condition with organic growth and deterioration at asphalt shingle roofs, and cracks and deterioration at concrete pads

Typical mailbox shelter

Expenditure Detail Notes: Expenditure timing and costs are depicted in the **Reserve Expenditures** table in Section 3. We recommend the Association budget for paint applications and repairs through the operating budget. Our cost for renovation includes:

- Replacement of the asphalt shingle roofs
- Replacement of the aluminum gutters and downspouts

- Partial replacement of up to fifty percent (50%) of the wood siding, trim, soffit and fascia
- Capital repairs to the masonry walls as needed
- Partial replacement of up to thirty-three percent (33.3%) of the concrete pads
- Replacement of the package boxes
- Capital repairs to the structural frames as needed

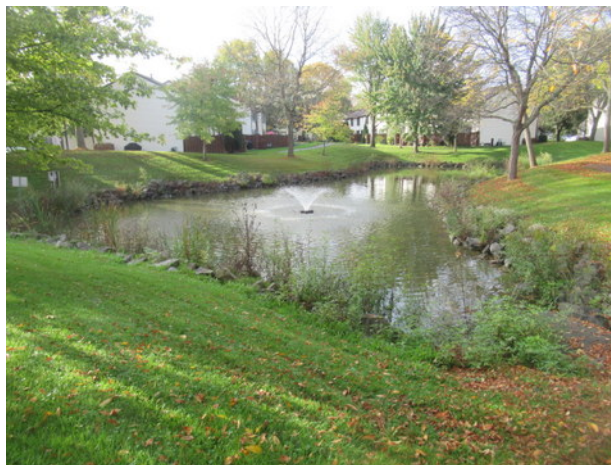
Condition: Good to fair overall condition; however, Management and the Board report a recent decline in water color and clarity.

Pond overview

Useful Life: Based on the visual condition, construction, adjacent deciduous trees and visibly apparent erosion, we recommend the Association anticipate the need to remove pond sediment up to 20 years.
